**STINSON LAKE DAM
NH 00399**

**PHASE I INSPECTION REPORT
NATIONAL DAM INSPECTION PROGRAM**

OCTOBER 1978

Name of Dam: Stinson Lake Dam, I.D. NH 00399
State Located: New Hampshire
County Located: Grafton
Stream: Stinson Brook
Date of Inspection: June 5, 1978

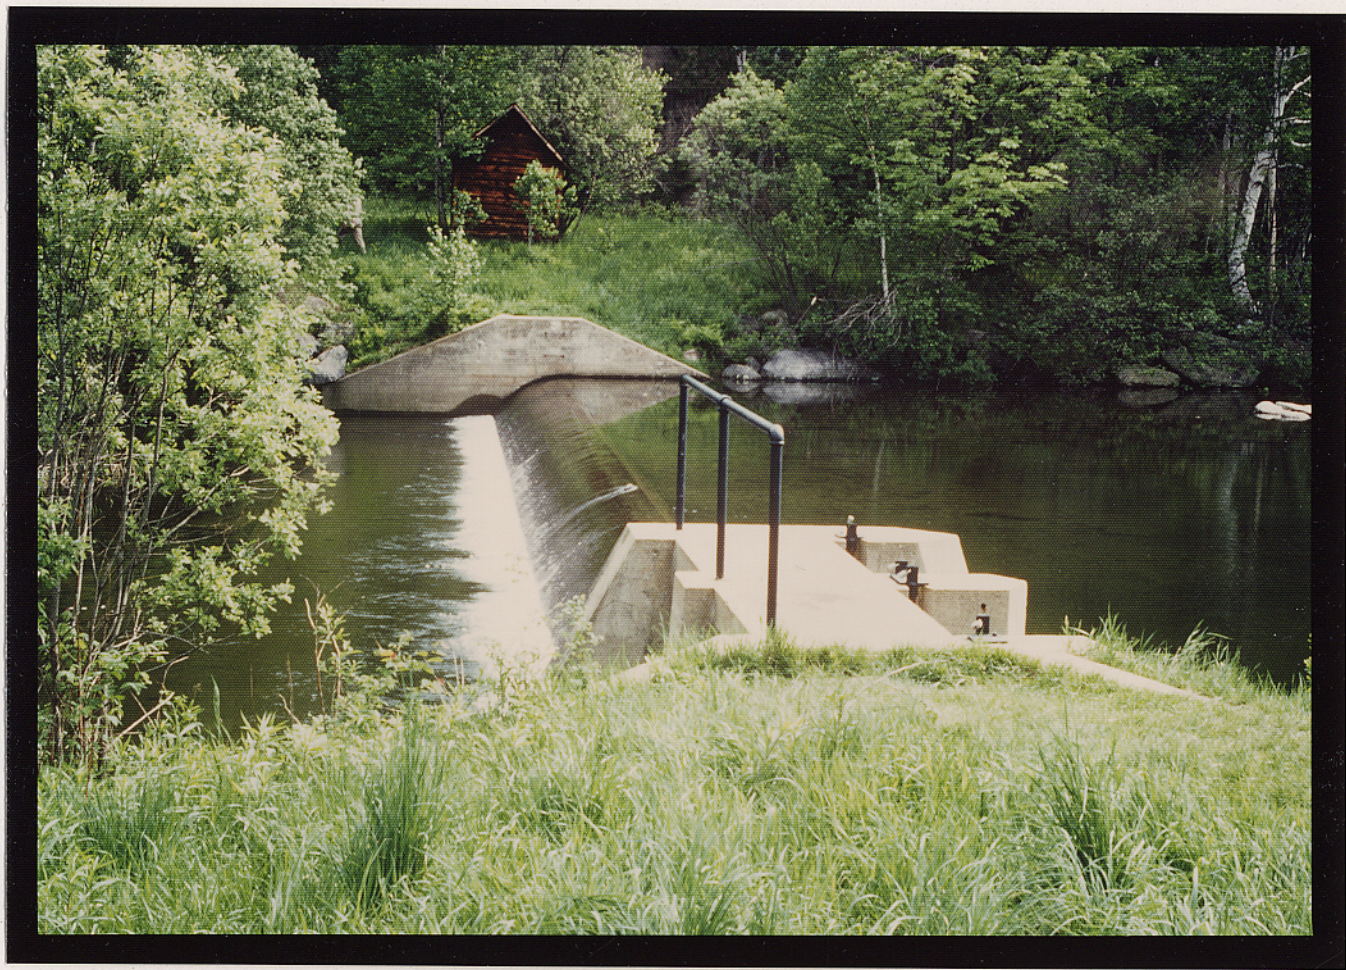
Looking toward the right abutment. The low level outlet stop plank section is in the foreground, on the left abutment.

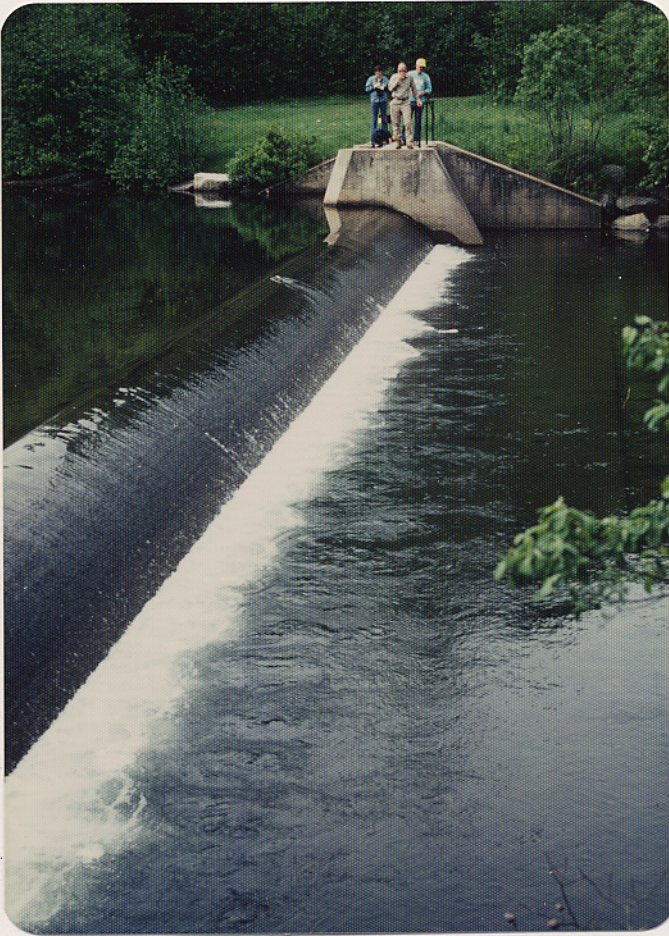
Photo 1 - View of the dam taken from the left abutment.

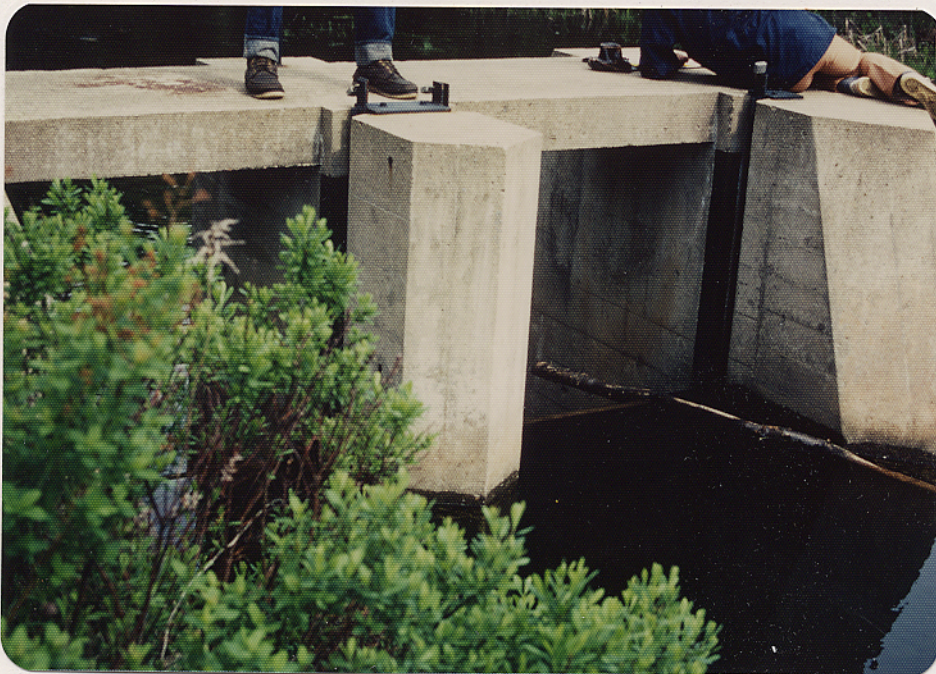
The concrete surfaces of the twin passages of the low level outlet showed no signs of deterioration. The stop log slots were cleanly formed and the stop log sections were in good serviceable condition. The access catwalk concrete was in good condition, allowing for the safe operation of the stop logs.

Photo 2 - View of the low level outlet stop plank section on the left abutment viewed from the upstream side.

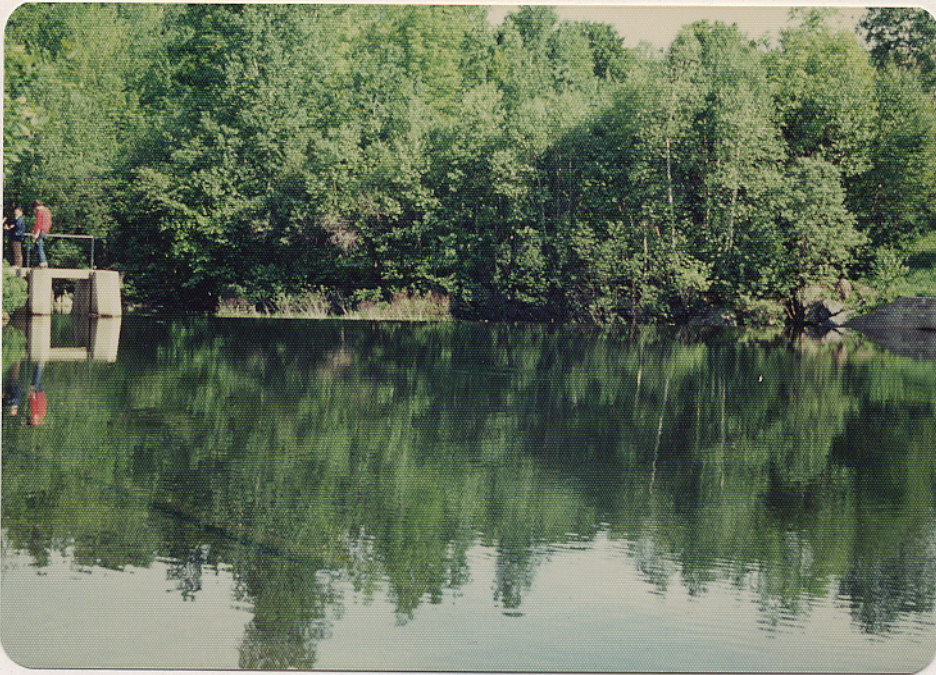
The spillway structure is well maintained and the approach channel is well defined, but heavy sedimentation deposits were observed in the reservoir on the upstream side of the spillway crest. No urbanization or new developments were noted in the reservoir area. The immediate downstream channel is also well defined with heavy riprap along the river banks.

Photo 3 - View of Stinson Lake Dam taken from the upstream side.

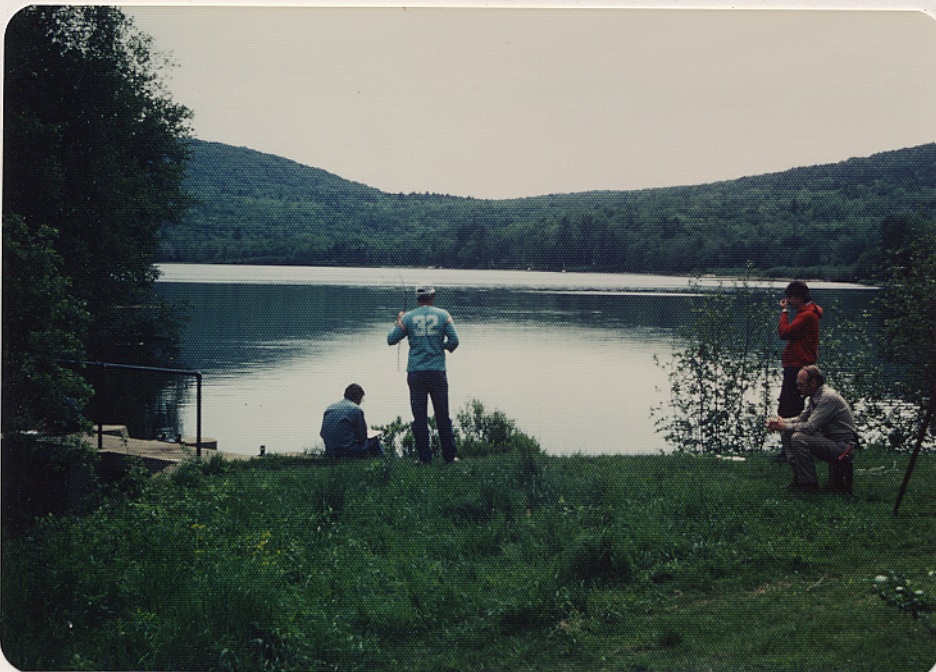
In general, up to a point 6 to 10 feet above the lake level, the lake rim is fairly flat, and then it slopes upward more sharply. No signs of instability of the terrain around the lake are readily apparent. The lake shore area is covered by trees and is sparsely developed. The shore is in the natural state and not protected against shoreline erosion except as noted above in the vicinity of the upstream spillway wingwalls. There are some signs of sedimentation at the right side of the spillway, where the approach channel appears to be significantly shallower than indicated on the dam drawings.

Photo 4 - View of the rim of Stinson Lake taken from the left abutment of the dam.

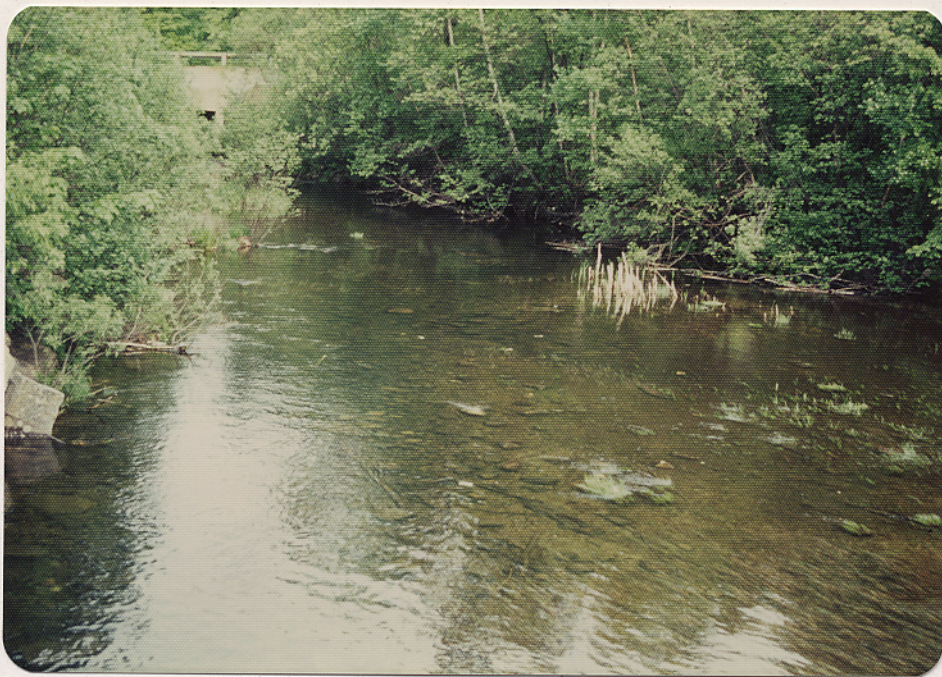
The immediate downstream channel is well defined with sharply sloping banks that have been protected by substantial riprap blocks for the first 100 feet downstream of the dam axis. The riprap protection was in good condition with no signs of sloughing or displacement. The riprap is in part overgrown with brush and small trees. Some aquatic growth was noted in the downstream channel, but this was not considered to affect the ability of the channel to convey the spillway discharges.

Photo 5 - View of the downstream channel from the left abutment, looking downstream.

(4) Selectively clear trees in area downstream of the main spillway that could be uprooted during high spillway discharges and cause damage to or plugging of the roadway bridge immediately downstream of dam.

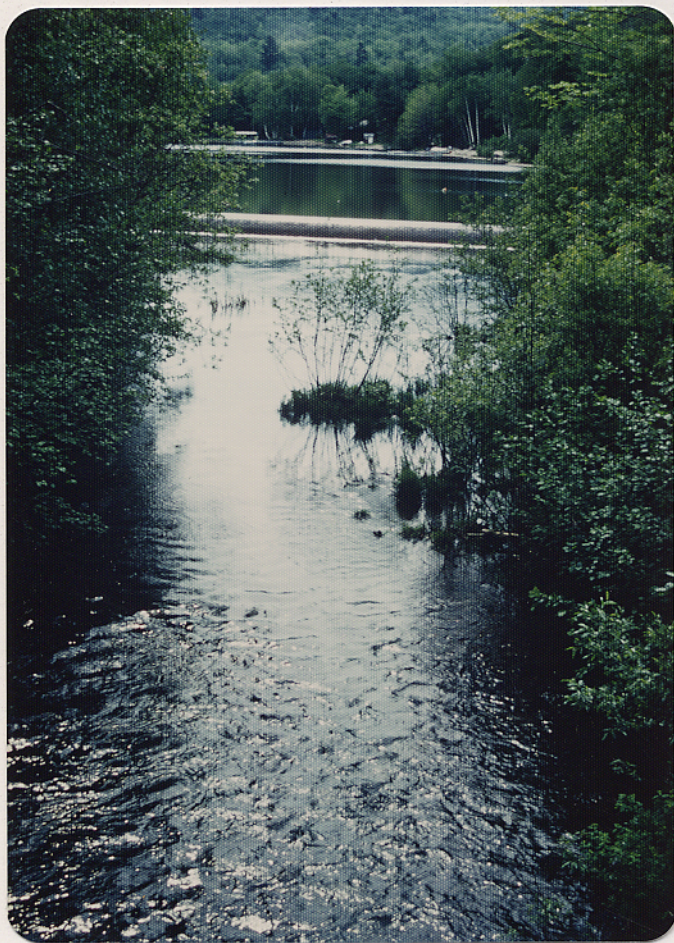
VISUAL EXAMINATION OF	OBSERVATIONS	REMARKS AND RECOMMENDATIONS
CONDITION (OBSTRUCTIONS, DEBRIS, ETC.)	No obstructions noted. A highway bridge crosses the stream some 80 yards downstream. There is some aquatic growth in the brook channel downstream of the spillway on the right side of the channel.	
SLOPES	Well defined, moderately steep and stabilized by heavy rip-rap stone protection.	
APPROXIMATE NUMBER OF HOMES AND POPULATION	One residence visible on left bank in the first 300 feet of the dam. There is sparse development along the brook in the 3.5 miles to the first population center downstream in Rumney, N.H.

Photo 6 - View of the downstream channel from the road crossing downstream of the dam. The spillway of the dam is in the background.
